# Manhole Inspection Summary

Manhole # S35C\_\_052MH

Insp Date: **8/6/08 3:57 PM**

**Location** Address: **rear 426 calvert st**

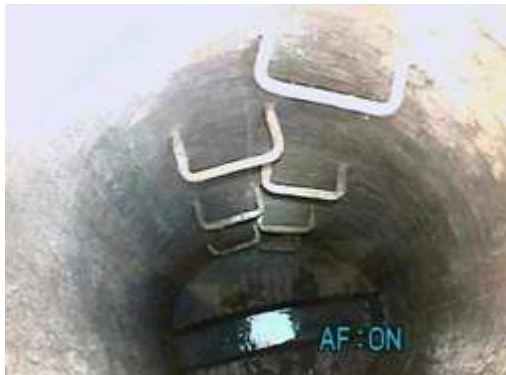
Defect 2

**Steps** Count: **8** Missing: **0** ☒ **Corroded**

steps

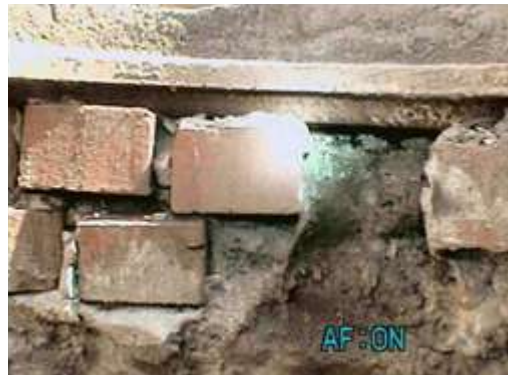
Defect 1

Condition: ☐ Sound ☒ **Cracked** ☐ Root Intrusion ☒ **Loose Brick** ☒ **Deteriorated**

Chimney loose bricks, cracked, deteriorated.

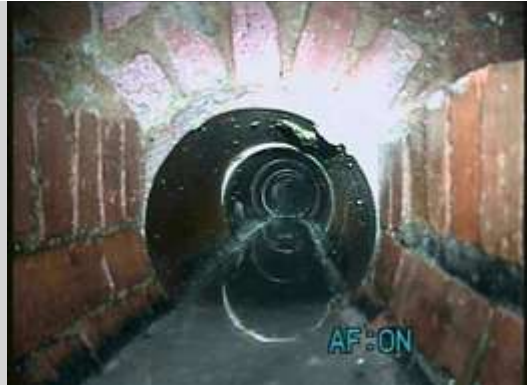
12 O'Clock Outflow

10 in. Circular Gravity Sewer  
Pipe Out @ 12 O'Clock

Infiltration: **None** Pipe Seal Cond: **Unknown**

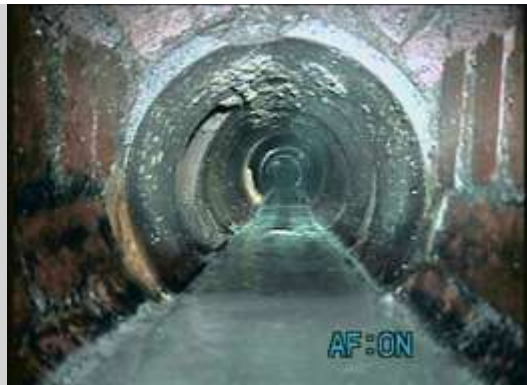
6 O'Clock Inflow

10 in. Circular Gravity Sewer  
Pipe In @ 6 O'Clock

Infiltration: **None** Pipe Seal Cond: **Unknown**
